LONDON- WEST MIDLANDS ENVIRONMENTAL STATEMENT

CFA25 | Castle Bromwich and Bromford

Data appendix (LQ-001-025)

Land quality

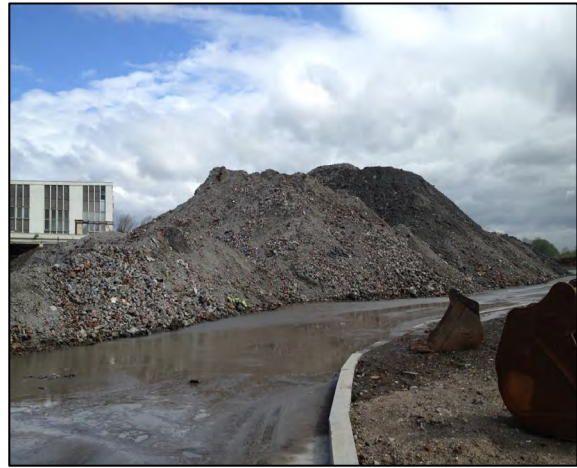
Photograph 2 - Ash Stockpiles

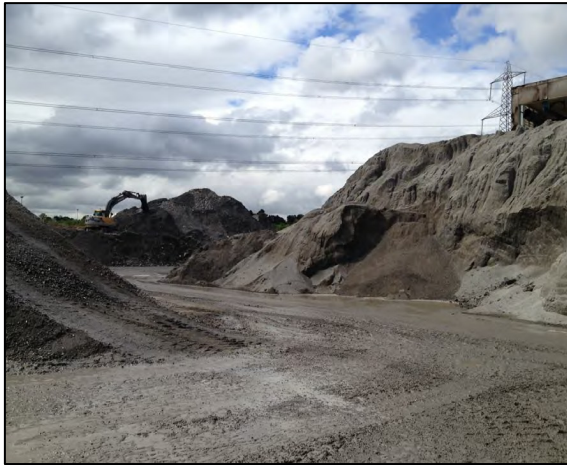
Photograph 3 - Ash Stockpiles

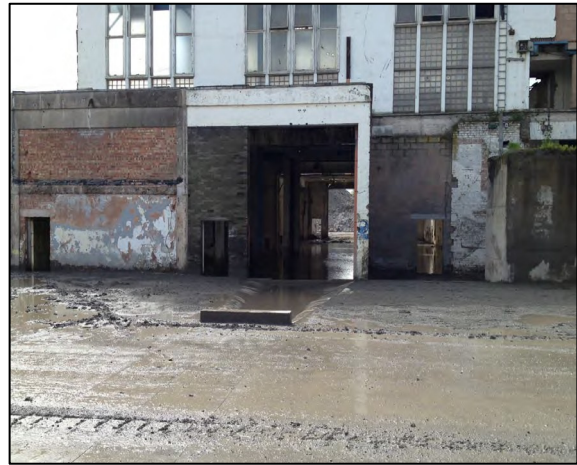
Photograph 4 - Drainage Sump

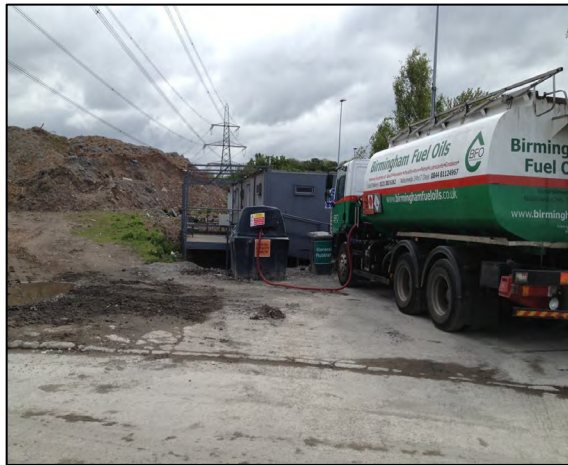
Photograph 9 - Red Diesel Tank

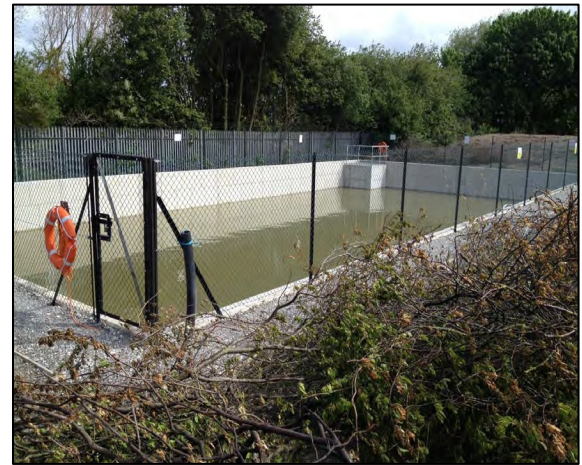
Photograph 10 - Settlement Pond
